WRIGHT GROUP INC.

Scott Blake

250 Edwards Boulevard
Lake Geneva, WI

INTRODUCTION:

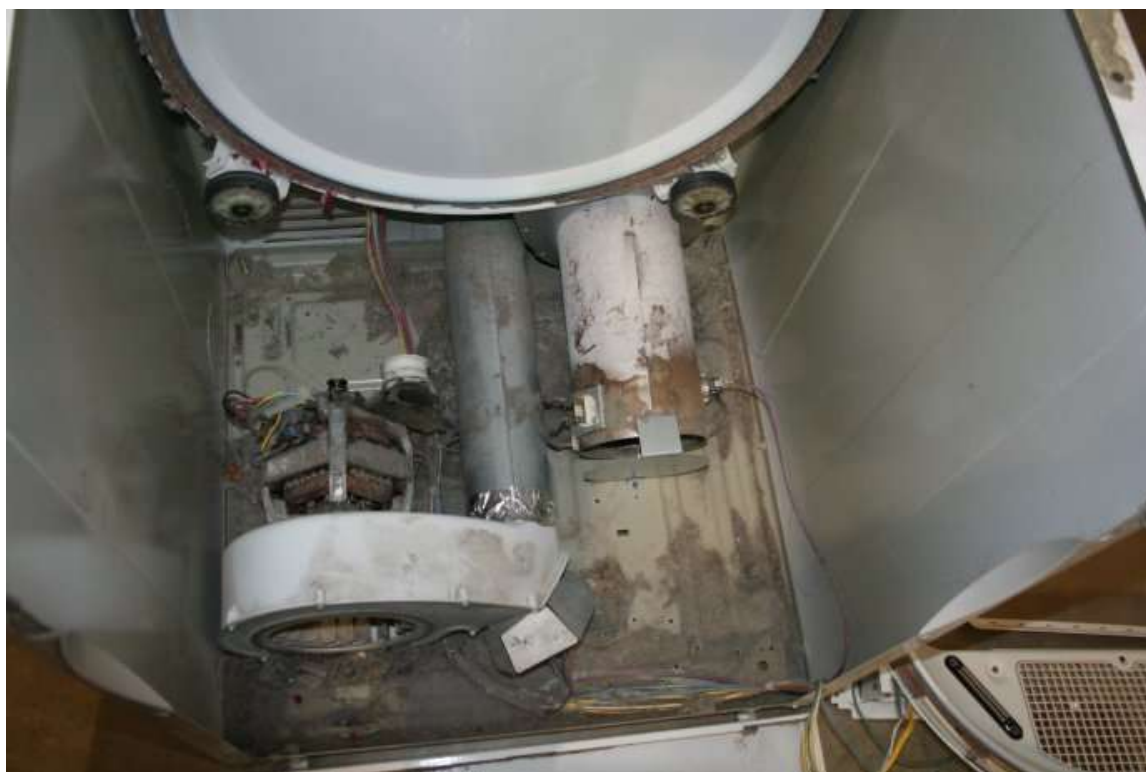
Photo 21: Used Maytag Dryer - Cabinet and Heater after Testing

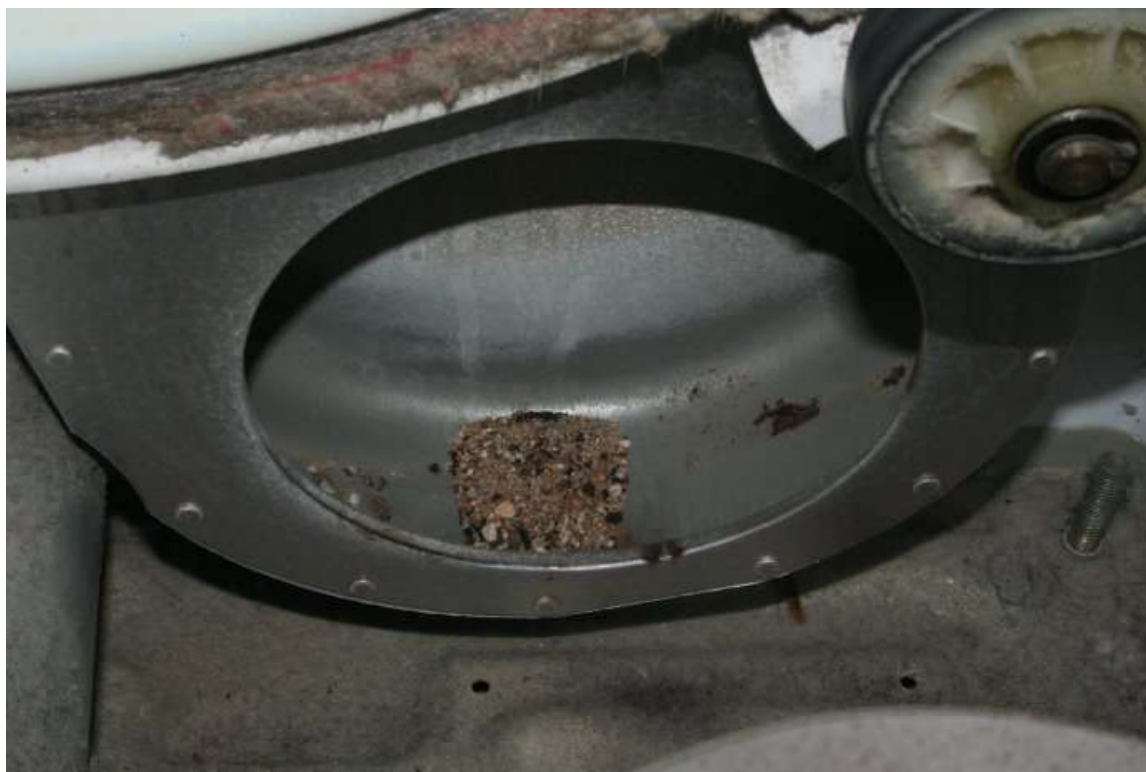
Photo 22: Used Maytag Dryer – Interior of Heat Duct after Testing
